Dry Creek

Purdin Ditch

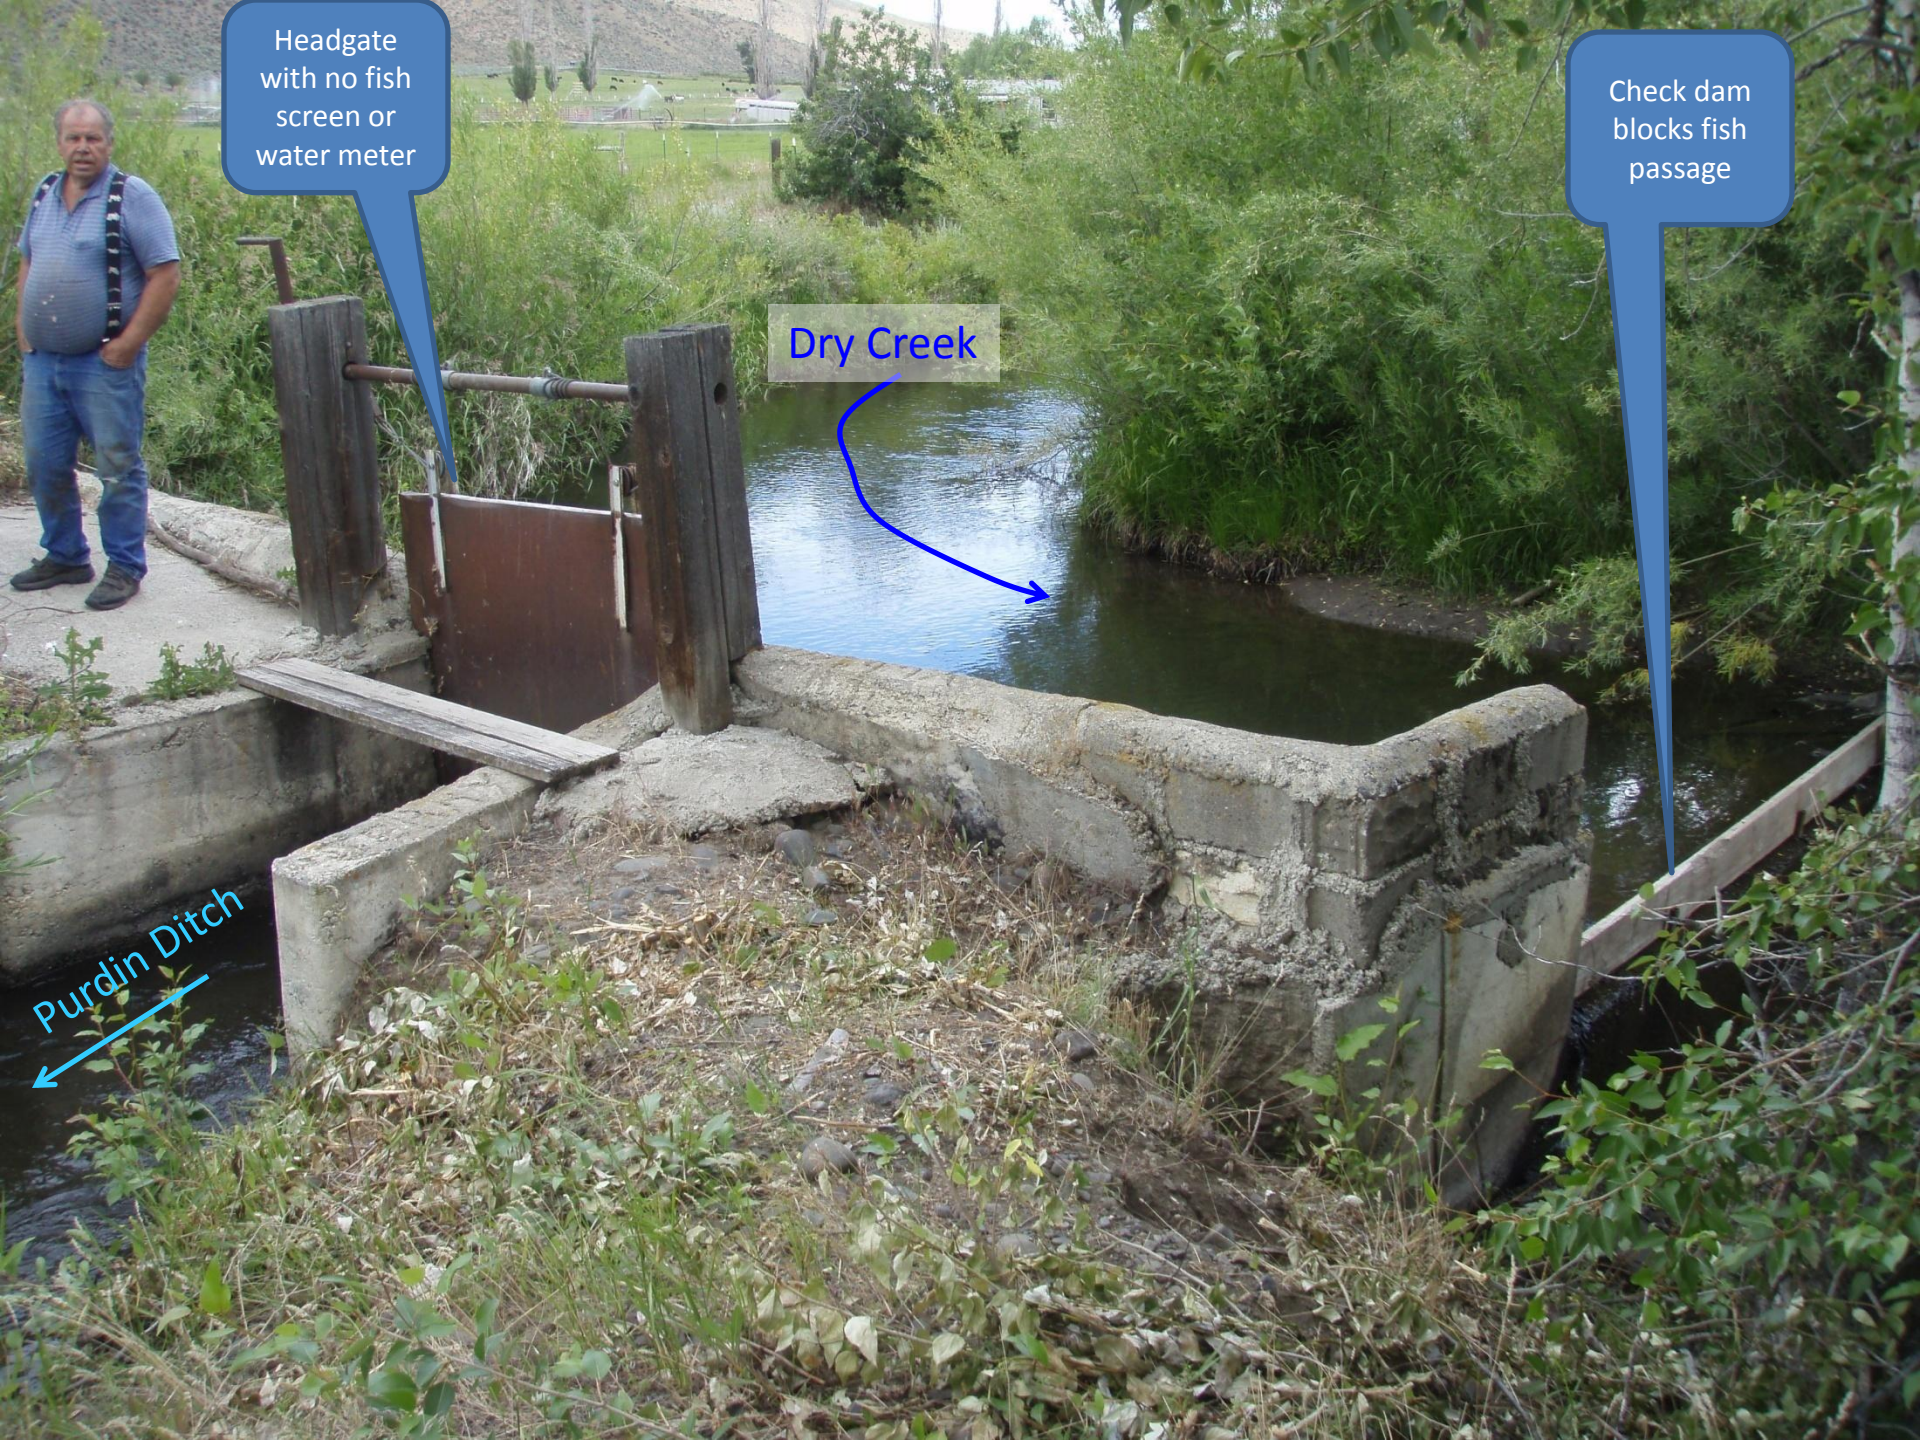
Headgate with no fish screen or water meter

Check dam blocks fish passage

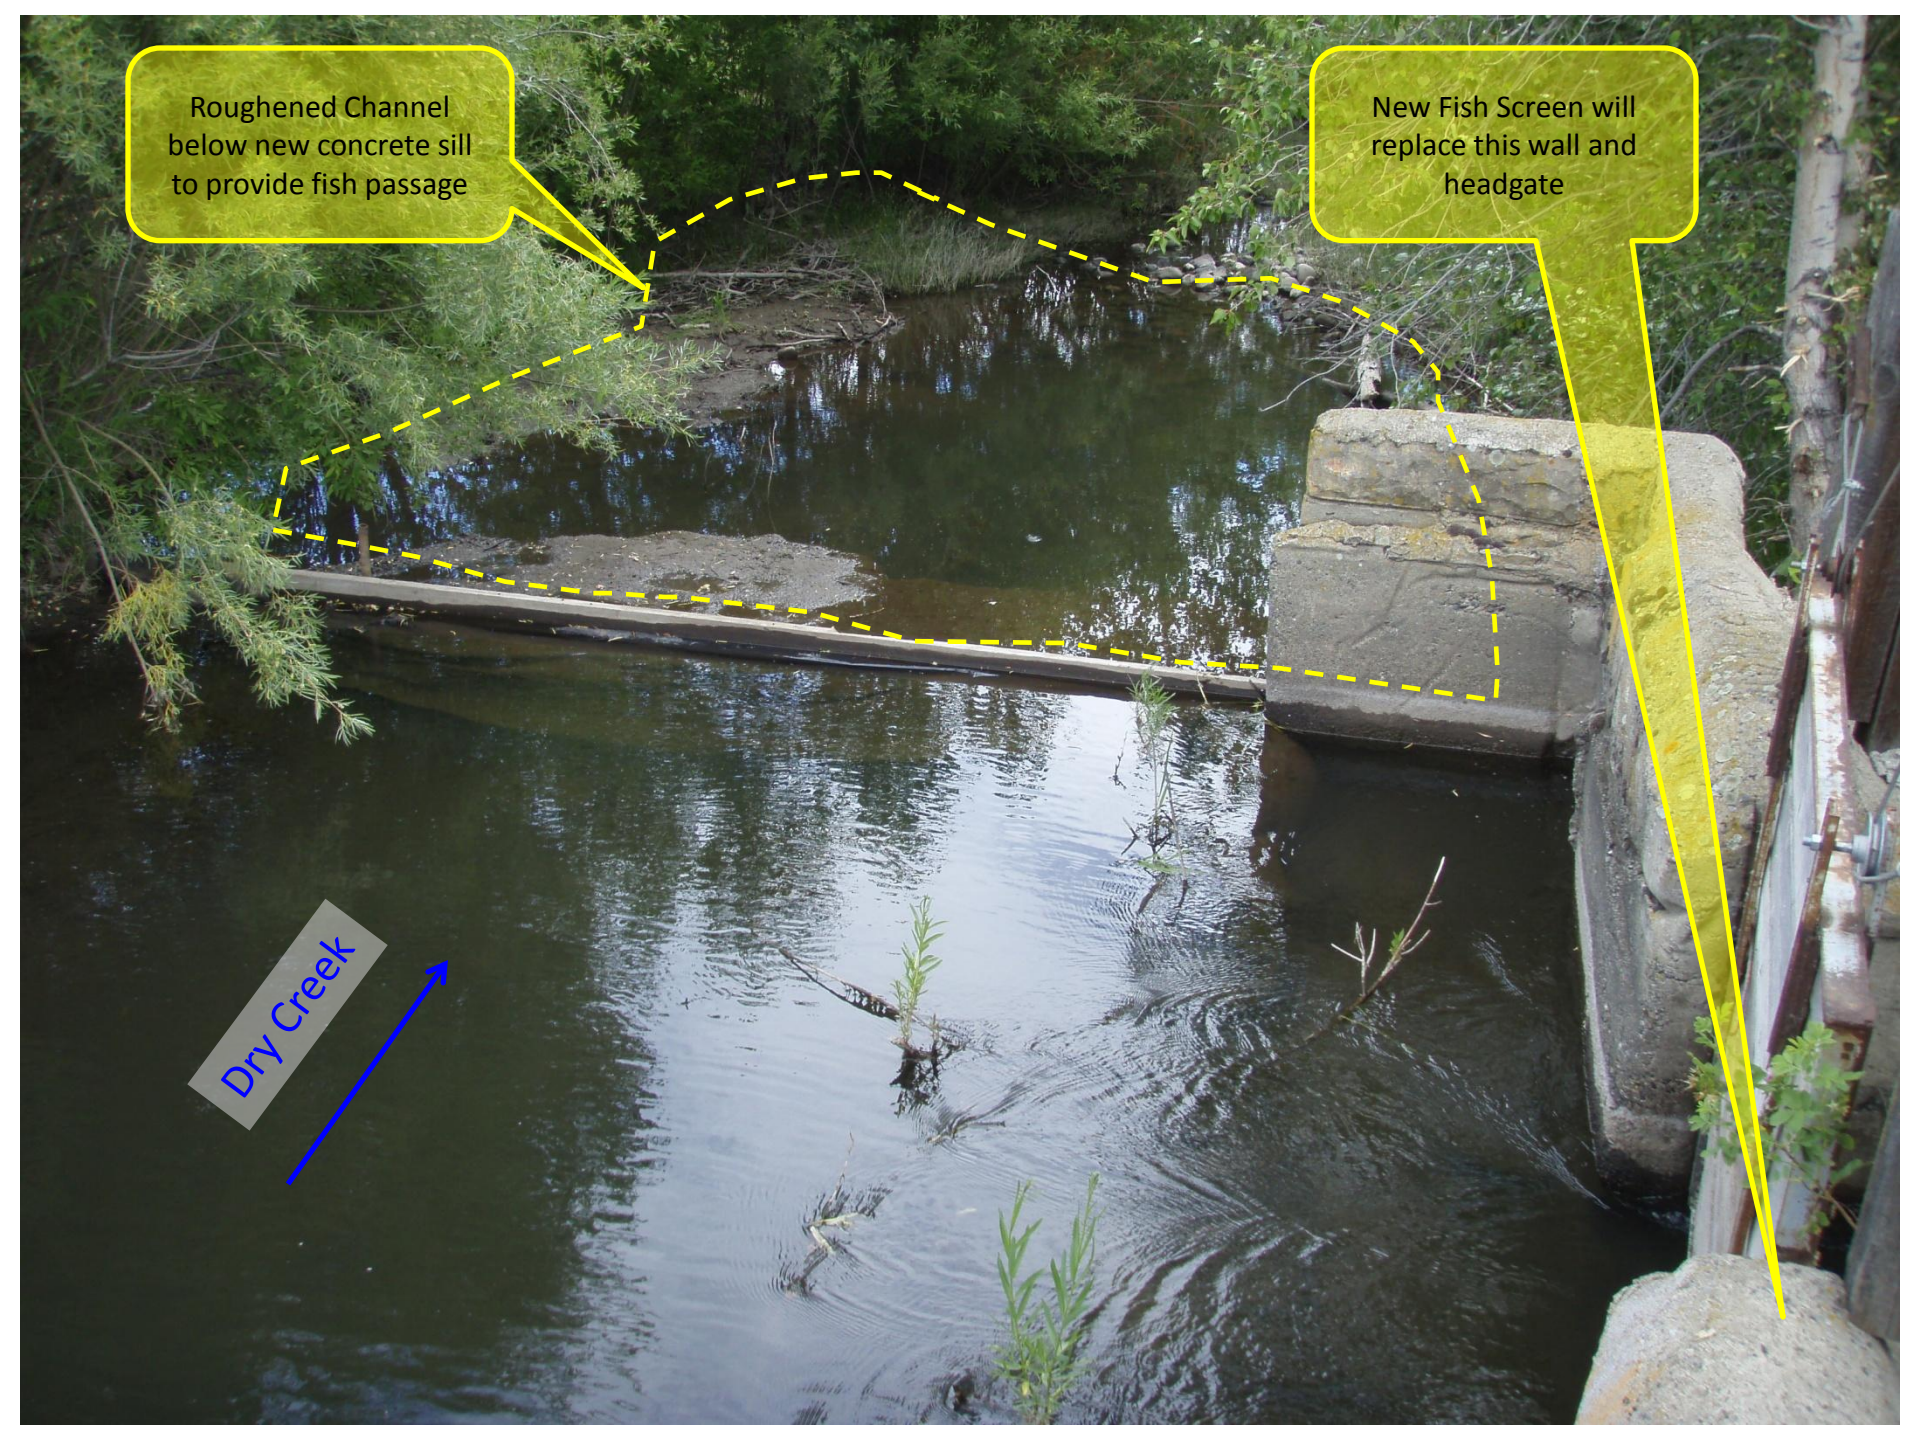
Roughened Channel
below new concrete sill
to provide fish passage

New Fish Screen will
replace this wall and
headgate

Dry Creek
